## **THIS OLD SILO: When Concrete Tower Silos Fail**

By Brian Aldrich, CCE Cayuga County  
August 2008

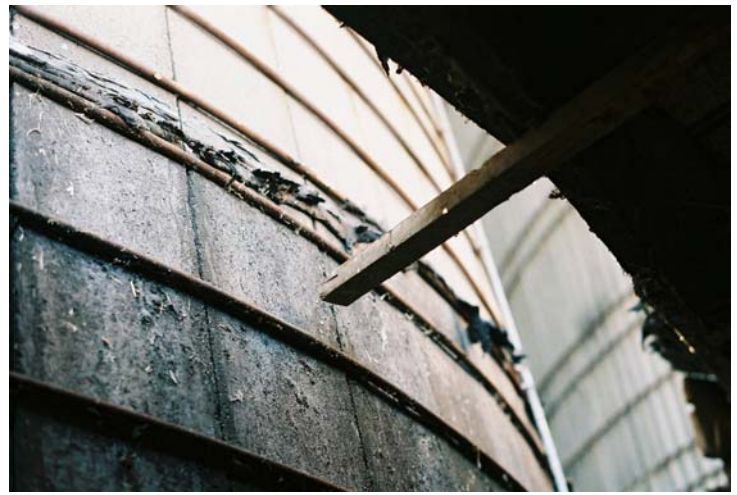
The photos below show how the silo looked last fall when it started to lean. The cause of the problem was that

Silo (left) pulling away from the barn. The board in the center was used to monitor the rate of shifting. Photo used with permission of owner.

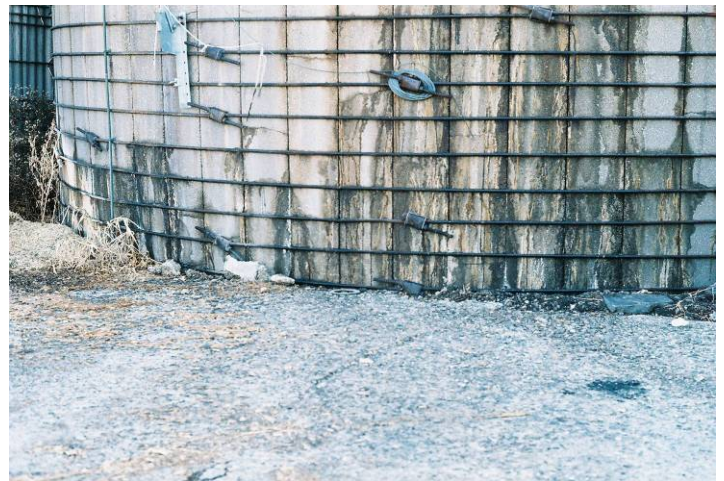
the silo's foundation was below grade (below the surface), and the drains surrounding the foundation had become plugged, allowing moisture to penetrate the bottom course of staves. Freeze-thaw cycles slowly degraded the staves over the decades. (This silo was built prior to 1971.) The staves at the base gradually weakened until they were finally crushed by the weight of the staves above.

Base of silo showing deterioration of bottom row of staves. Photo used with permission of owner.

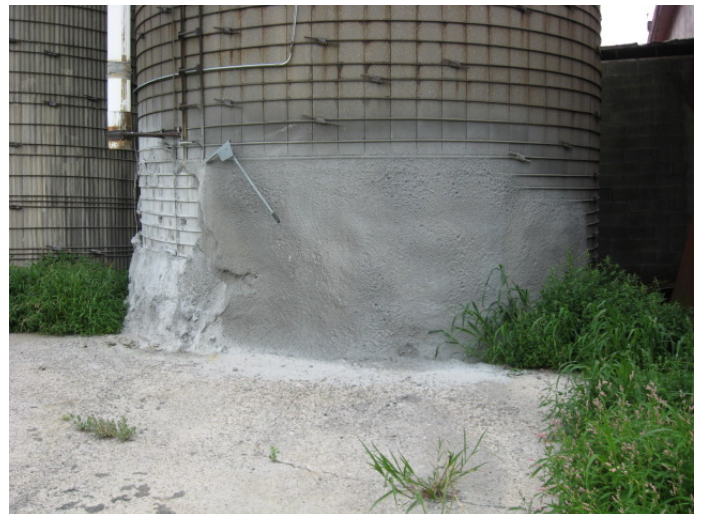
Base of silo temporarily reinforced with "shotcrete" concrete. Photo taken July 2008, used with permission of owner. The silo will be taken down this fall.

stabilize it by reinforcing the bottom with “shotcrete” concrete that was sprayed on (see photo).
